AREPA Municipal Water Supply Facility Fire

Incident

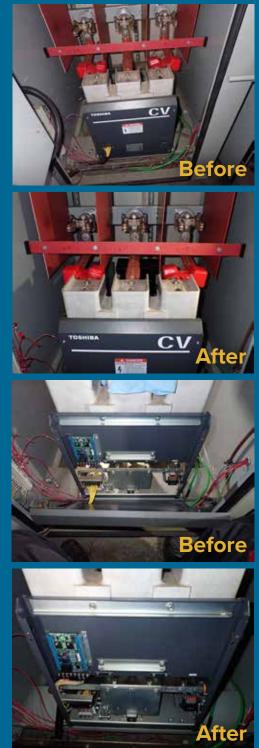
Photos

The fire damage required disconnecting the main high-voltage electrical power from the building. The one large Variable Frequency Drive (VFD) in the main building was the source of the fire damage and required replacement. The replacement process was projected to take over six months due to equipment availability. Additionally, the remaining PLC controls, transformers, and high-voltage switchgear in the building were contaminated and needed thorough decontamination before the replacement pump drive could be installed. A second adjacent pump power building maintained temporary power for essential heating and freeze protection during the winter months.

Time sensitivity was a significant factor, as restoration needed to be completed before the new year to ensure operational readiness for the replacement pump drive. The project involved decontamination of high-voltage switchgear, transformers, breaker panels, PLC control panels, and safety disconnect switches.

AREPA successfully restored all recoverable equipment within the affected building. The restoration was completed on time, meeting the year-end deadline and ensuring the facility's readiness for the installation of the replacement pump drive.
