IS BITCOIN MINING INSURABLE?

EXAMPLES AND LOSS CHARACTERISTICS

INSURANCE CONSIDERATIONS FOR BITCOIN MINING EQUIPMENT

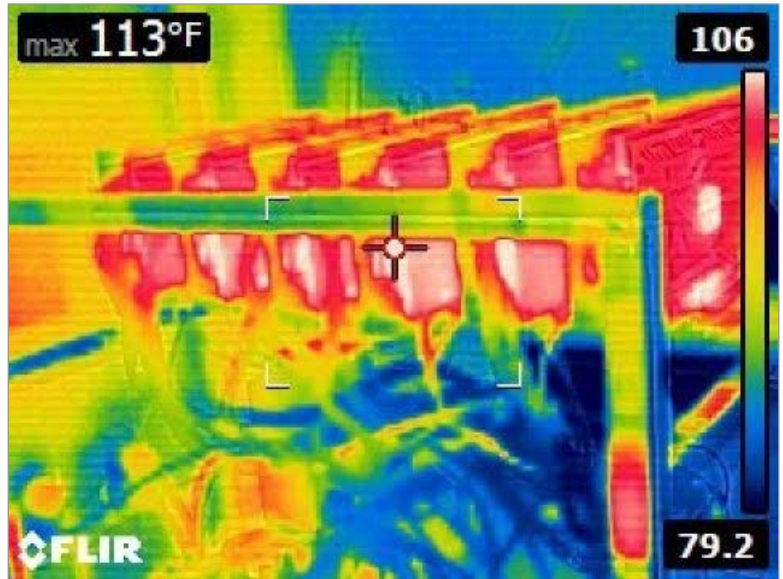
Thermal imaging of six graphic processing units. Picture credit The Bitcoin Miner.

The picture displays a thermally imaged mining rig with six graphics processing units. The blue shaded areas are cold versus the yellow and red that exhibit temperatures of up to 113°F.

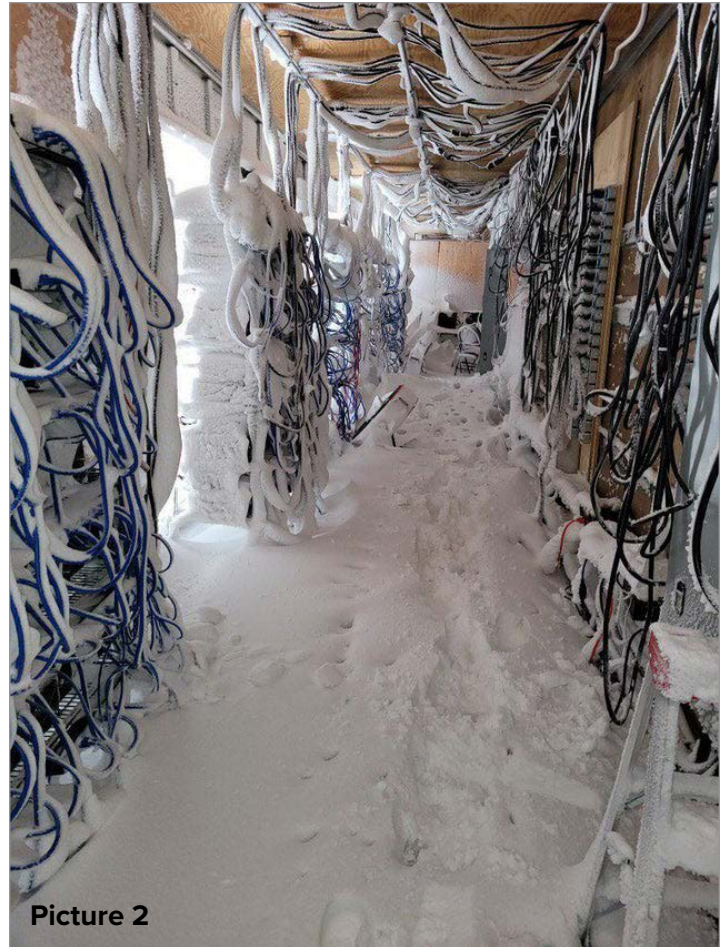
Equipment exposed to harsh elements. Pictures credit Reddit member EasyRider1975.

Picture 1 - A shipping container retrofitted for mining applications. Based on the snow accumulation, it could be argued that the equipment was not powered on during the event, and snow was introduced from the same direction as the person who took the picture, or from right to left. Did the container lose power and a door was inadvertently left open?

Picture 2 - A structure that is housing equipment although not originally designed for this sort of application either. Irrespective of how the snow was introduced, which appears to be from the left opening, the insurance claim is the same as in Picture 1.

2. Environmental impact - Equipment that requires decontamination before it can be powered on for testing.

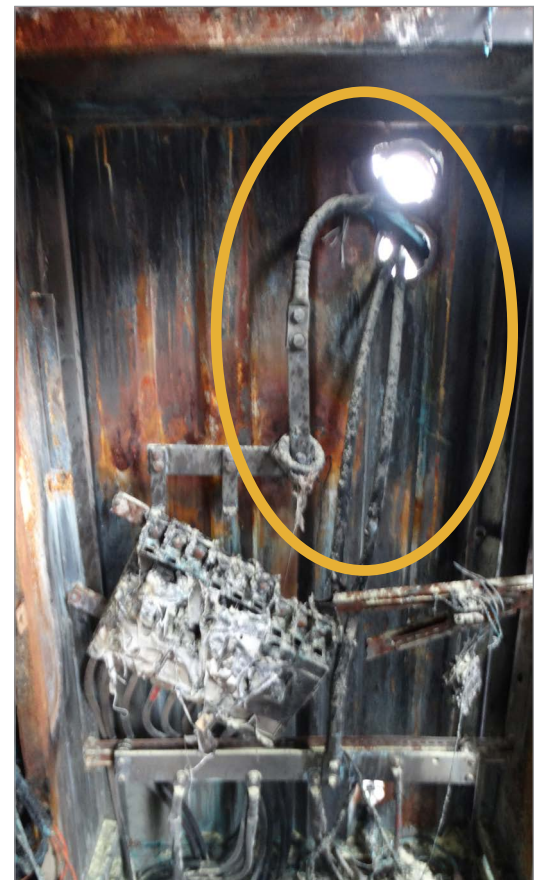
Fire in one of two shipping containers that house Bitcoin mining servers. The containers are stored outdoors in front of large transformers that energize the servers inside. The fire consumed the majority of the container contents. The origin appeared to be the power distribution panel within the container (circled in yellow on the right). A closer look at the 480V cable that enters the panel revealed chafing. Chafing is damage to the insulation and shielding of a wire. This is typically caused by wires rubbing against each other or a rough surface.

The cable was inserted through a hole on the back of the container. A protection sleeve was not installed in neither one of the observed holes. The wiring insulation was touching the bare steel. The claimed electrical arc explosion and resulting fire were likely a result of a combination of inadequate protection around the hole in the cabinet, and large side mounted fans causing the container to vibrate such that over time the cable insulation chafed, which eventually exposed the electrical wiring. The wiring came in contact with the container, which is grounded, and caused a short circuit. This is an example of improper installation that would not meet code in a regular structure.

The electrical cable chaffed wiring insulation in contact with the container. Picture credit Envista Forensics.

4. Improper installation - Bitcoin servers were consumed and require replacement. The servers in the container that did not exhibit heat damage should be decontaminated.
